STOUGHTON LAKE DAM
(BEAVER DAM)

NDI No. PA 00468
PennDER No. 56-78

PHASE I INSPECTION REPORT
NATIONAL DAM INSPECTION PROGRAM

Stoughton Lake Dam (Beaver Dam), Somerset County, Pennsylvania
NDI No. PA 00468, PennDER No. 56-78
Beaverdam Creek
Inspected 12 December 1979

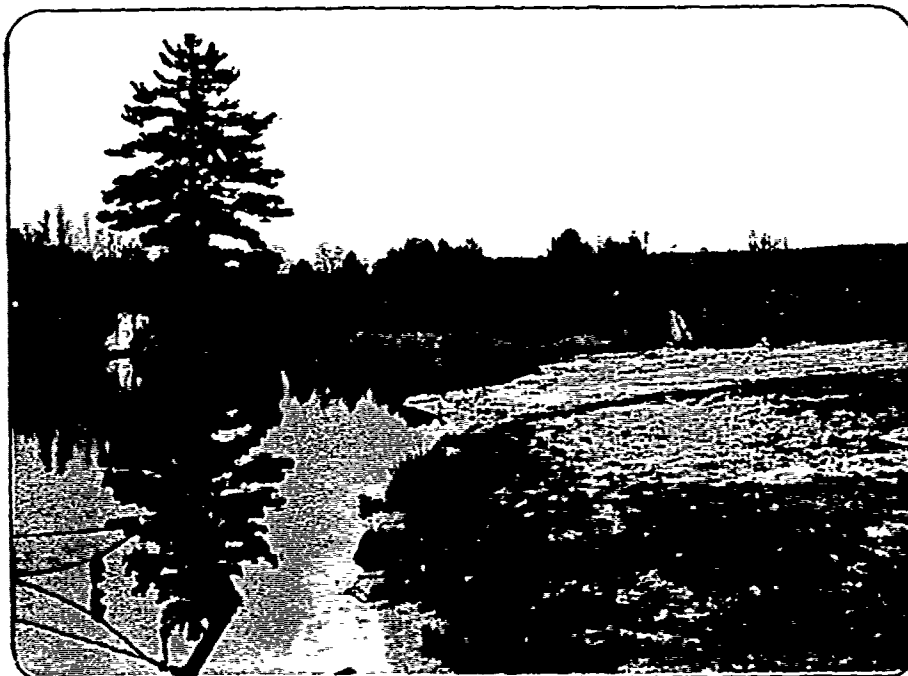
- c. Appurtenant Structures - At the time of inspection the right spillway training wall was being reconstructed. The embankment/abutment behind the wall had been excavated and the downstream half of the wall removed. The wall footing was left in place to serve as the foundation for the replacement wall consisting of masonry stone construction. The remaining upstream portion of the training wall was tilted and disjointed from the cut-off section (transition buttress). It should be noted

PHOTO 1. View of Spillway Entrance
(Note excavation behind the right training wall)

- 1) Reconstruct the spillway training walls.
- 2) Repair or reconstruct the spillway discharge apron. It would be advantageous for the continued stability of the ogee section to have the engineer examine for undermining of the ogee section after the reservoir has been drawn down.

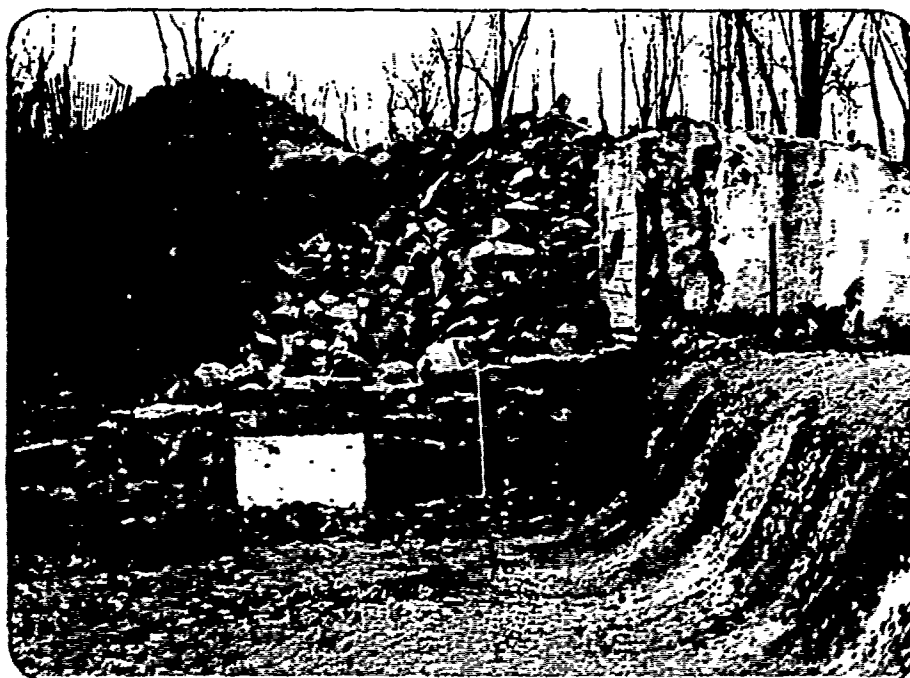
that these repairs were being performed under normal pool conditions which is an undesirable construction practice. In addition, some of the backfill material may be susceptible to piping if proper transition filters and proper drainage systems are not installed. Evidence of this could be seen along the downstream end of the completed wall where minor amounts of seepage/drainage from the backfill was carrying fine particles and also around the outlet head wall where erosion has occurred.

PHOTO 3. View of Repairs to Right Spillway Training Wall

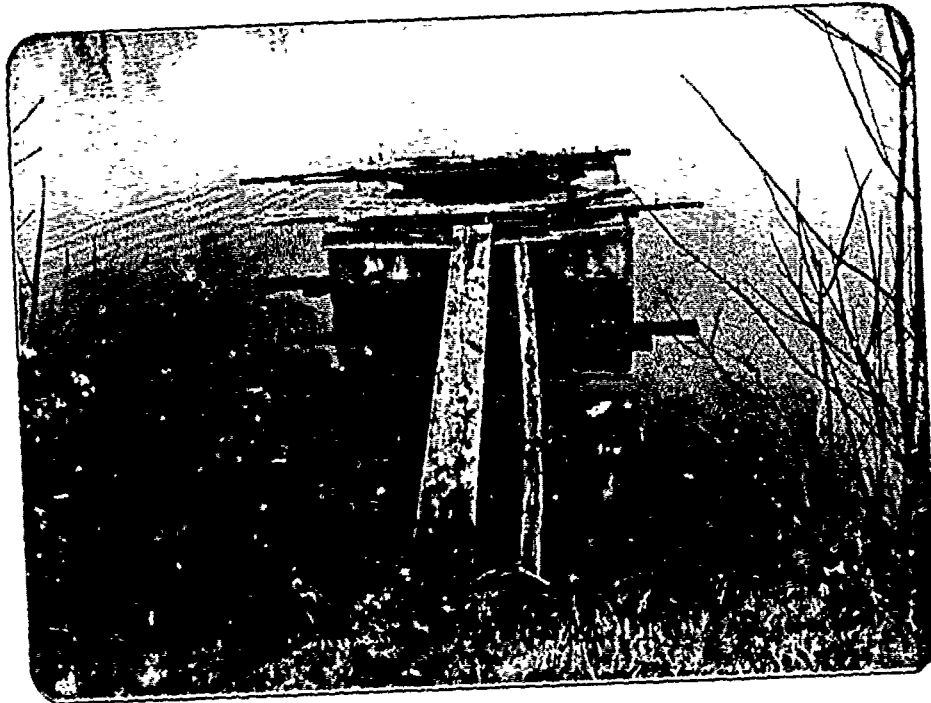
The intake structure for the outlet works is submerged and could not be observed. The riser unit was in good overall condition except for some spalling of the concrete at the water line on the outside. The stop logs in the riser which divide the riser into two chambers were in good condition where they could be examined. However, it must be noted that displaced stop logs were observed in the downstream chamber indicating that these stop logs may need to be replaced.

PHOTO 7. View of Intake Structure

- 5) Repair the spalled concrete on the outside of the intake riser at the water line.
- 6) Reshaping the discharge channel for the outlet works will eliminate the backwater on this structure. By eliminating the backwater, the surges may be decreased or possibly eliminated.

- 7) As a part of the annual inspection the saturated condition of the embankment near the outlet head wall should be examined and recorded.
- 8) Stop logs in the intake riser should be replaced in the future as their condition demands.
